Research Article

Participatory Assessment of Agriculture Land and Vegetation Associated Issues and Possible Interventions in Gurage Zone, Ethiopia

Bethel Nekir^{1,*}, Tesfaye Yaekob¹, Fetta Negash², Teshome Bekele¹

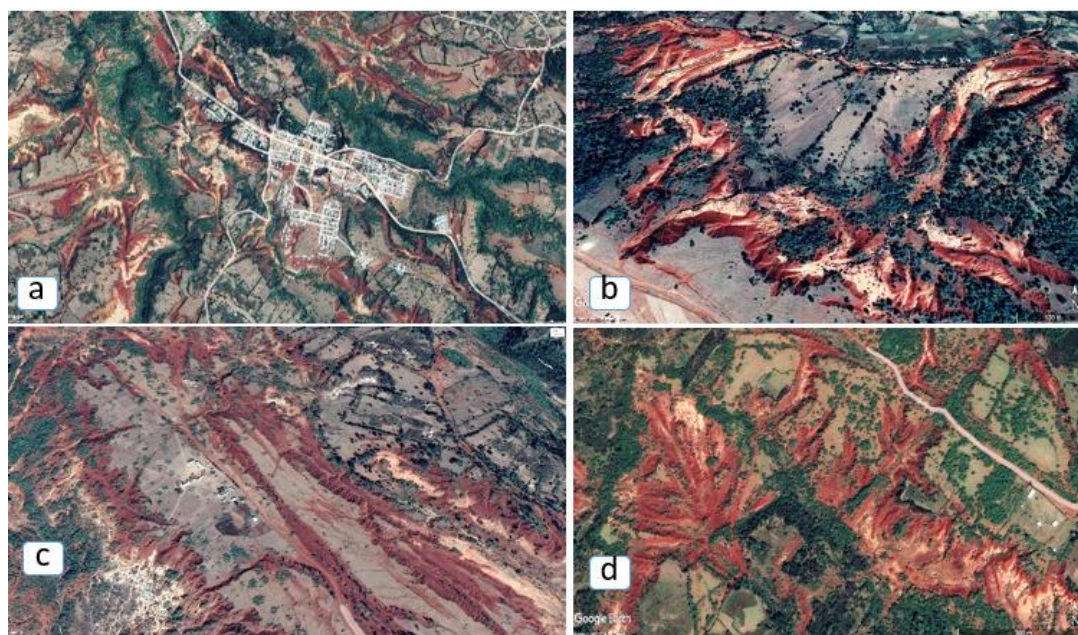
Figure 2. Land degradation google earth photo at Gurage zone a) Muhr Aklil District nearby Hawaryat town b) Muhr Aklil District Koror kebele c) kokir Gedebano District Ameto kebele and d) Cheha District at boreder of awakir and stepa kebele.

In the Gurage zone, different types of erosions are found to be the biggest challenges. Even though, erosion has been observed throughout the surveyed districts, the intensity was found to be high in Cheha, Gutazer Gedebano Wolene, Endegagn, Muhr Aklil, and Enemor districts. During the group discussions farmers and agricultural experts confirmed that currently soil erosion problem is increasing in extent and severity. The satellite picture below also illustrates unless a quick and appropriate measure has been taken due to soil erosion a large portion of land will be lost within a few years (Figure 2).

The survey result depicts that sheet and rill erosion are commonly observed in farmlands whereas gullies are common in communal lands and edges of farmlands caused by field runoff. At Sodo, Abeshege, South Sodo, Mareko and Meskan districts gully erosion found to be a common problem and it is increasing at an alarming rate. In Cheha, Enemore, Gutazer Gedabano Wolene, Muhir Aklil districts, considera-

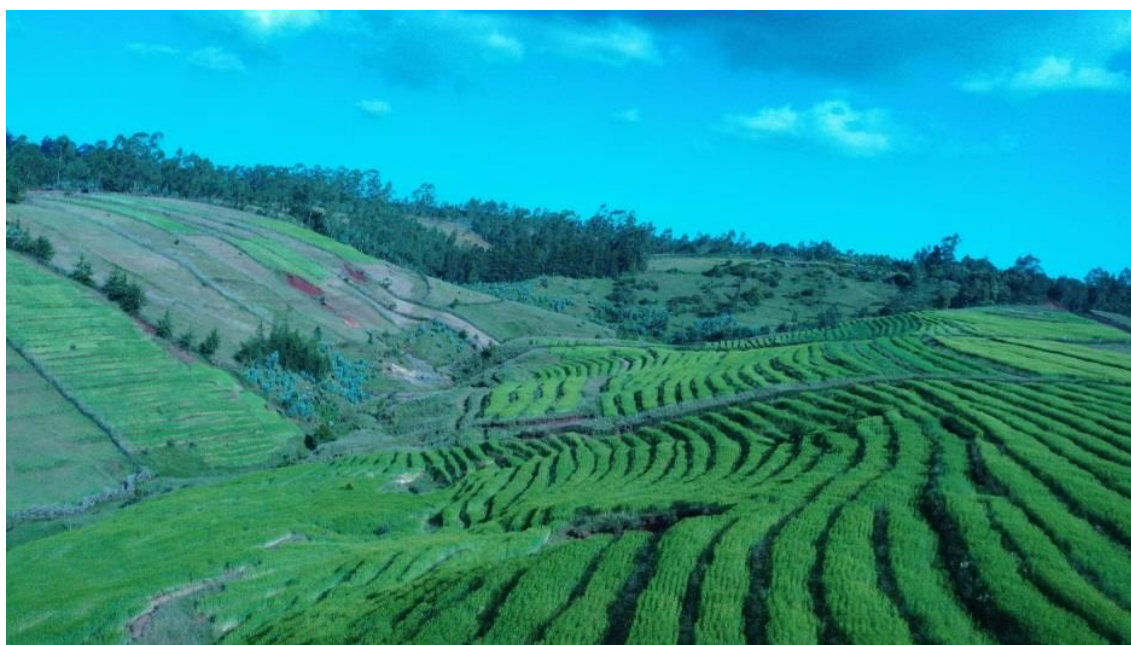
Figure 3. Bench terrace for soil and water conservation at Gumer District Jemboke Kebele.

Despite the Gurage zone's efforts to address the issue of land degradation, still need a lot of work. Annually, in February the zone holds a campaign to save soil and water [16]. In the campaigns, the whole farmers participate continuously for thirty days. Currently, promising terraced fields, bench terraces and physical and biological soil and water conservation structures and area closures to prevent further degradation are common Gurage zone (Figure 3). Depending on the agroecology of the area, different cereal and potato crops are grown on the terraces. In order to stabilize the structures at the edge stripe forage desho grass (*Pennisetum Pedicellatum*) is most often planted. According to [13] agroforestry, terracing, and cut-and-carry system can be integrated to sustainably manage erosion-prone areas of steep mountains area.

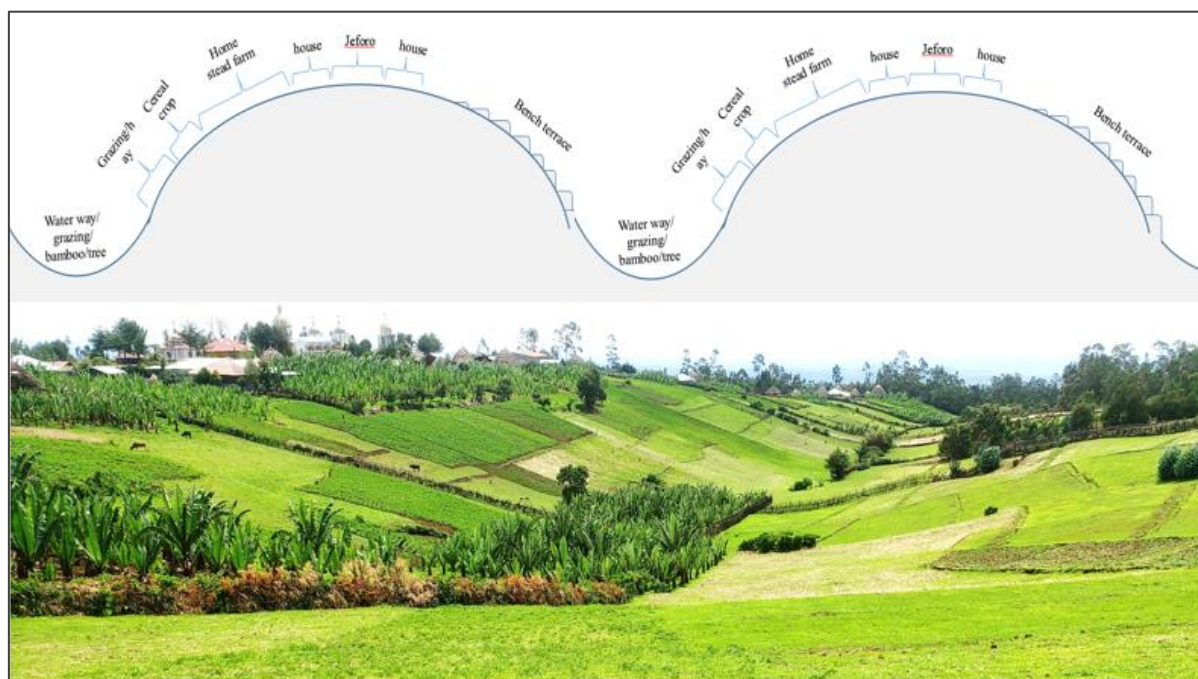
Figure 4. In the highland of Gurage Zone commonly practiced land use along slope.

The topography and land setting of the Gurage Zone consists of gorges and flat lands (Figure 4). The majority of the land is undulating and rolling topography with a slope of above 8%. Moreover, it is prone to land degradation and surface runoff that needs special care to use for agricultural purposes. The land use pattern across slopes clearly show that gentle to steep slopes lands are allocated in the mid land for cereal production and in the highland for Jefore and production of cereals. Jefore is a free green land space between two oppositely set settlements with a function of all social gatherings, grazing, children's playground and other functions (Figure 4). Plateau topography is preferred for "Jefore" and house construction while steep slopes for homestead farms, this type of land use along slopes is unusual in most parts of

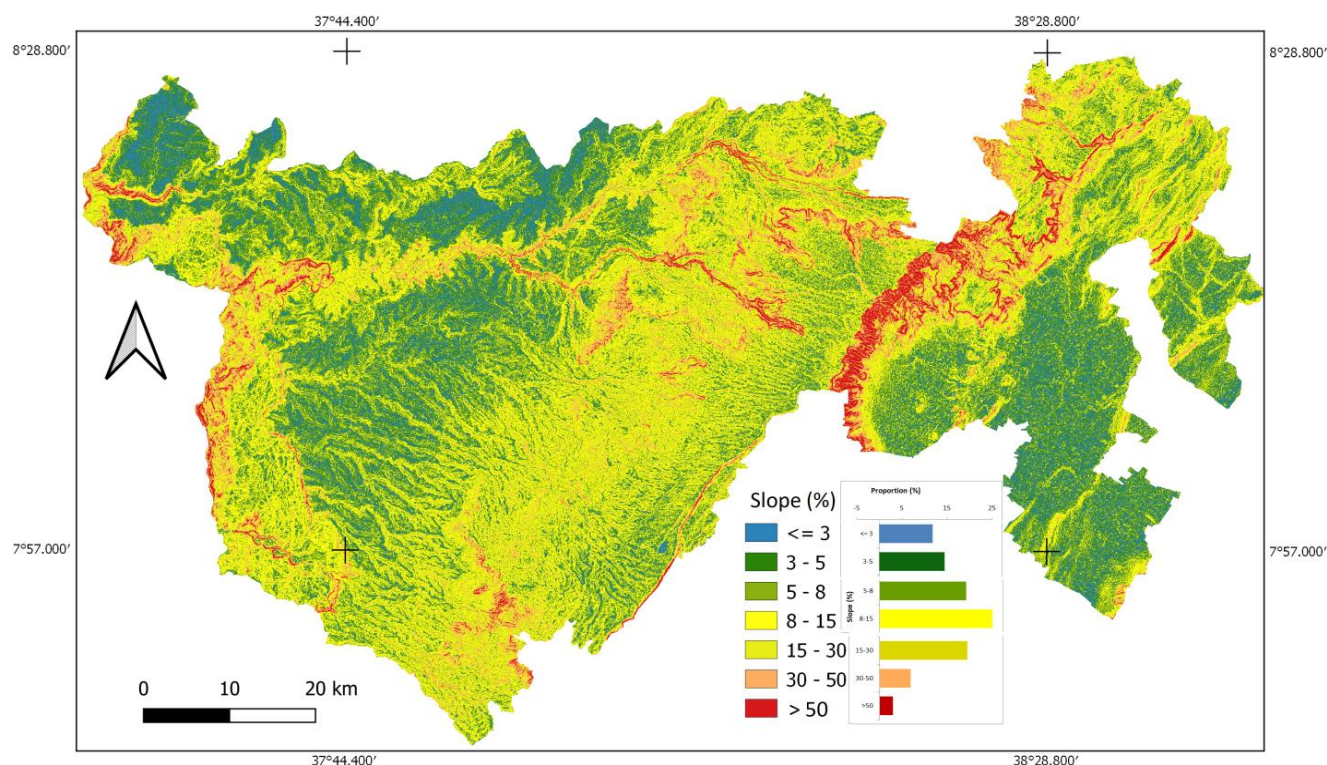
Figure 5. Slope map of Gurage Zone.

Figure 5 illustrates the very steep (20-35%) and extreme (>35%) slope gradients in Gurage Zone that are dominantly found along with Zebidar Mountain in the districts of Gedebano Gutazer Welene, Ezha, Muhr Aklil and Gumer districts and along Gibe Valley at Abeshge, Cheha, and Enemor districts. Since the terrain in these districts is unsuitable for mechanized farming, local hand tools are typically used for the majority of farming operations. Generally mountainous areas of Gurage are characterized by steep slopes, rugged

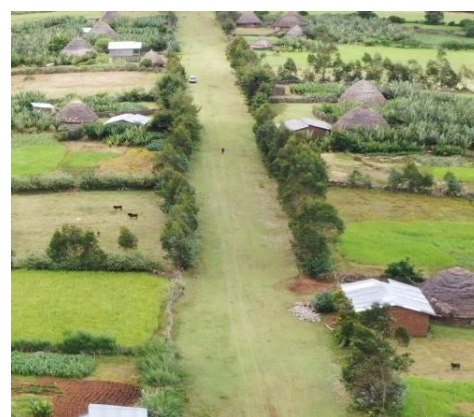
Figure 6. Cultural land landscape (Jefore) Ezha districts.

Jefore roads are multifunctional roads that have been designed and managed by local people for centuries [23]. The Gurage are people in Ethiopia that formed village settlements based on the ecological conditions linked to Jefore roads and Enset culture [25]. Jefore is a multipurpose landscape that the community uses mainly for recreational, cultural and social events for gatherings, holidays and animal grazing land. Jefore is a distinct feature and value that Gurage people practicing. However, the discussants of the survey pointed out that the heritage is in danger due to mishandlings. The survey team also observed that the land feature is currently under risk because of poor land management, road construction and expansion of land area by the nearby land owners. Because of the mismanagement, Jefore has been threatened with its cultural, social and recreational values. There is a need to recognize the importance of traditional landscapes, and to mainstream policy and decision-making regarding sustainable management before these landscapes disappear completely. Jefore is used not only as a cultural land, but also important as agricultural land in the Gurage where is used as grazing land for livestock production. It is currently suffering from unnecessary damage and facing problems that diminish its previous role, so it should be given important attention by the communities and concerned bodies.

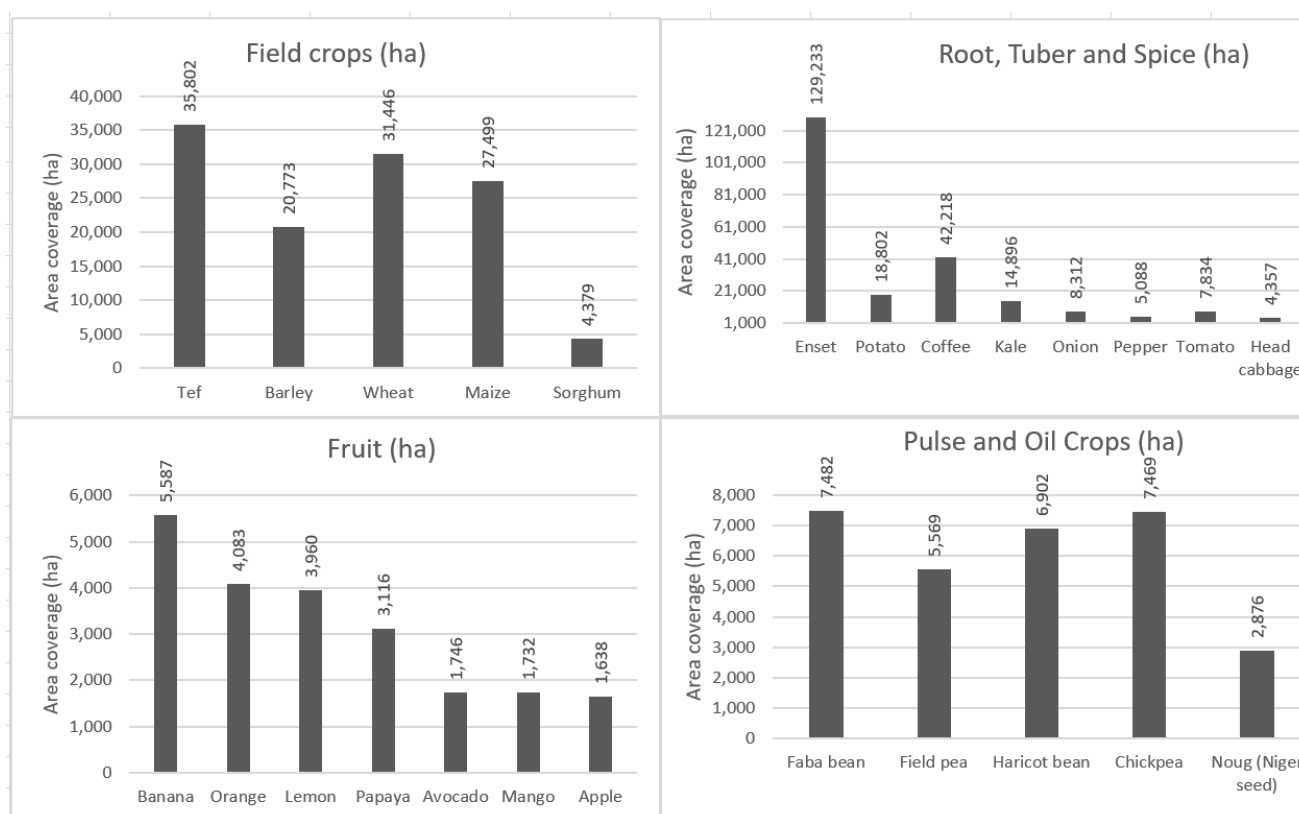
**Figure 7.** Gurage zone crop production area coverage (GZAD, 2019).
